North American Performance Validation

For
AESTHETICS
and
DURABILITY
the choice for buildings is
PREPAINTED
55% Al-Zn
COATED STEEL

This report covers surveys of established metal buildings utilizing both prepainted 55% Al-Zn coated, and prepainted hot-dip galvanized, steels in the most aggressive acid rain zones of North America.

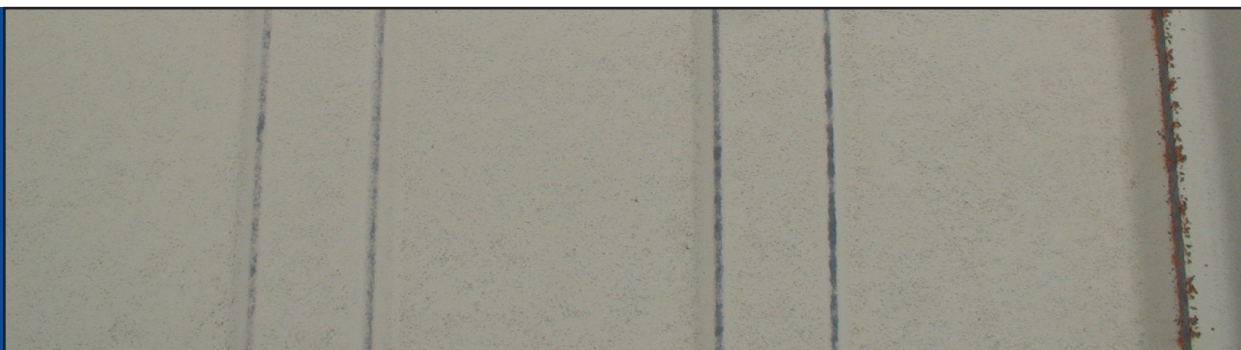
PREPAINTED
HOT-DIP GALVANIZED

Corrosion performance at buildings in rural/acid rain Ontario: hot-dip galvanized after 21 years; 55%Al-Zn coating after 17.5 years.
